# Manhole Inspection Summary

Manhole # S390\_\_005MH

Record Plat: **390** Node: **005** Status: **New Manhole (Not in GIS)** Insp Date: **10/14/08 12:00 AM**

**Location** Address: **904 valencia ct**

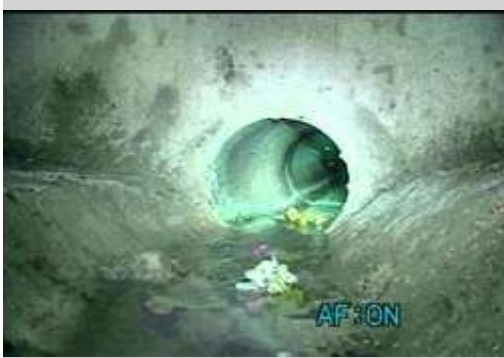
Misc

channel debris

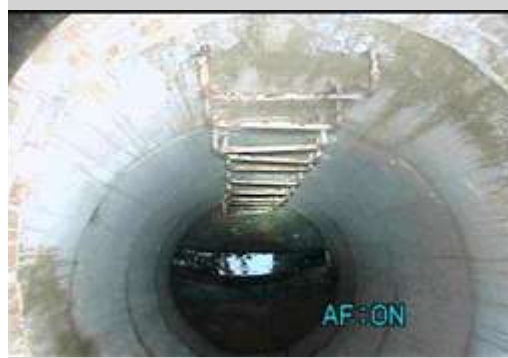
Defect 1

**Steps** Count: **12** Missing: **0** ☒ **Corroded**

corr steps

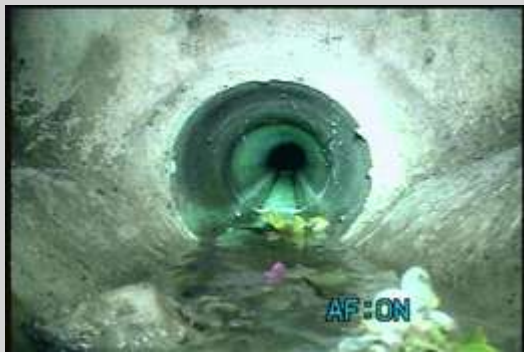
12 O'Clock Outflow

8 in. Circular Gravity Sewer  
Pipe Out @ 12 O'Clock

Invert Depth: 14.20 (ft.) Flow Characteristics: Slow

Infiltration: None Pipe Seal Cond: Unknown

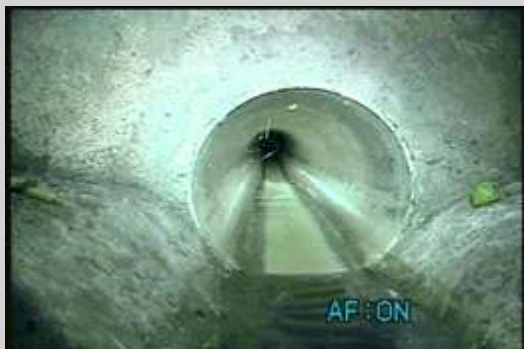
5 O'Clock Inflow

8 in. Circular Gravity Sewer  
Pipe In @ 5 O'Clock

Invert Depth: 14.00 (ft.) Flow Characteristics: Slow

Infiltration: None Pipe Seal Cond: Unknown
